MPC8641 Chip Errata

This document details all known silicon errata for the MPC8641 and MPC8641D devices. The following table provides a revision history for this document.

Errata in this document also apply to the MPC8640 and MPC8640D.

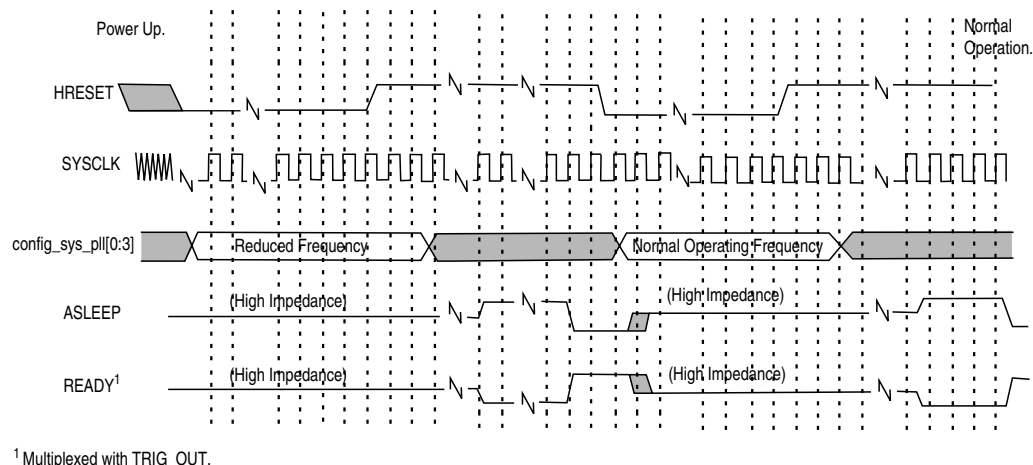
Figure 1. e600 Work Around Timing Diagram

e600 5: Cache failures may occur due to mis-sampled repair fuse information

Description: The device design implements cache array “repair” after wafer fabrication by configuring fuses to replace defective arrays in the L1, L2, L2 tag, and L2 status arrays in the event that a defect is detected. This fuse array is read whenever the device is reset in order to determine which cache addresses have been reassigned to a redundant array. Due to marginal timing on the read logic on the fuse circuitry, the fuse data may not be read after negation of HRESET. If bit(s) in this fuse array are not read, the redundant array will not replace the defective array.

1. Power up, observing the power sequencing requirements in the hardware specifications.
2. During initial HRESET assertion, configure the cfg_sys_pll[0:3] signals so that the resulting platform frequency is between 200 and 300 MHz. Note that cfg_platform_freq does not have to be pulled down at this time and cfg_core_pll can remain configured for normal operating conditions.

7. Proceed through the reset sequence as normal, observing requirements for the Power-On Reset Sequence stipulated in the device reference manual.
8. Proceed with normal system operation.

The recommended procedure is illustrated in Figure 1 .

Note that this work around is required only during power-up. Once the processor has successfully read the fuse values at the lower platform frequency used in step 2, the values are latched and subsequent resets (with power maintained) at the higher platform frequency used in step 6 will not result in failures.
